# TECHNICAL SERVICE POINTER

Technical Service Pointer: W11287497

## COMMERCIAL LAUNDRY Front-Load Washer Belt Change

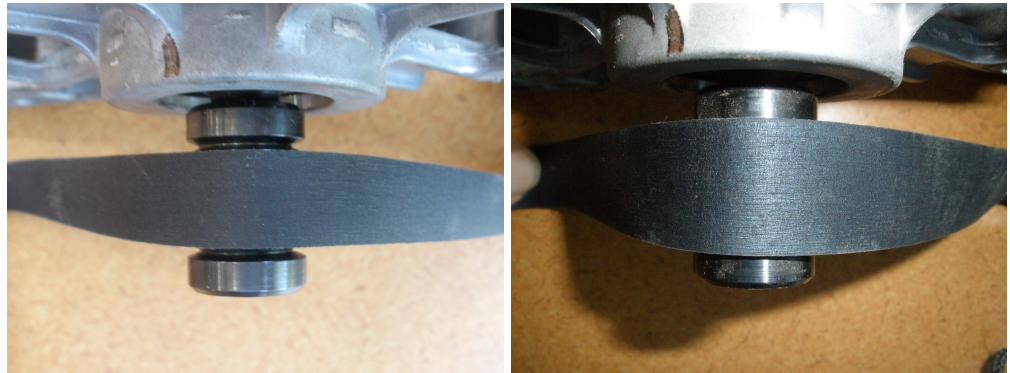
Front-load washers may experience belt slippage and / or premature belt wear. This can be evidenced by belt dust accumulation and spin or basket speed issues.

Starting in early August with serial numbers beginning at C831, production will implement an 8-rib belt, replacing the current 6-rib belt. The 8-rib belt will provide higher performance and reliability from belt wear and slippage. The 8-rib belt is available as service part number WPW10388418.
