| <b>Technical Service Pointer</b> | <b>For Immediate Attention of Your Service Department</b> | |

Technical Service Pointer #: W11329116C  
Action Required: Mandatory  
Release Date: January, 2019

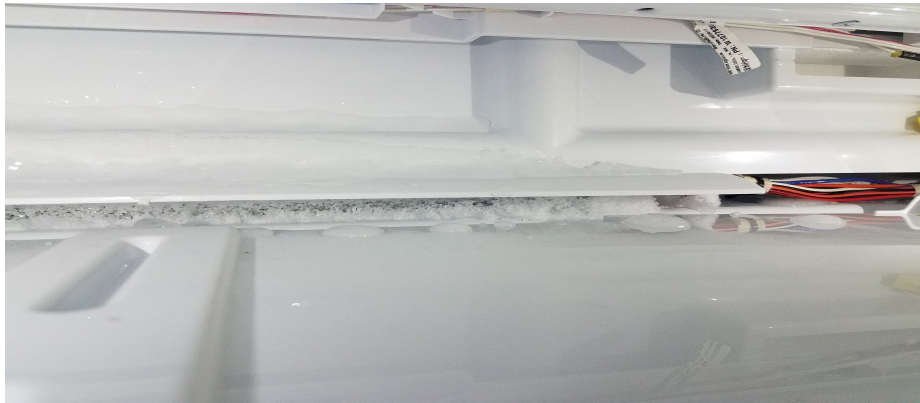
**Figure 2 - ICE VISIBLE AFTER REMOVAL OF BOTTOM DRAWER**

3. Using a hand held steamer, completely defrost the evaporator coil before installing the replacement cover.
4. Confirm all frost is removed, if frost/ice is not completely removed condition can reoccur.

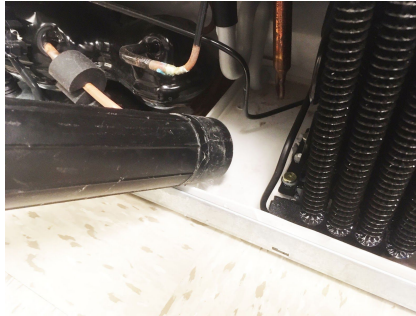
**Figure 4 - DRAIN PAN WATER REMOVAL**

5. Vacuum remaining water from the RC cabinet
6. Remove the machine compartment cover, and vacuum water from the drain pan Figure #2.

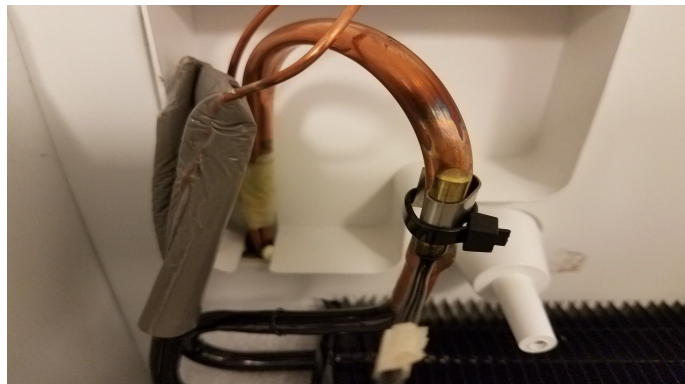
- Proper placement.
- Too high on the U bend.
- Loose or off.
- Not making full contact.

**Figure 5 - CORRECT THERMISTOR LOCATION**

7. Make a note in claims report of the original position of the thermistor - Compared to the picture of The correct thermistor position below in Figure #5. Use the following to note the original position in the claims report:

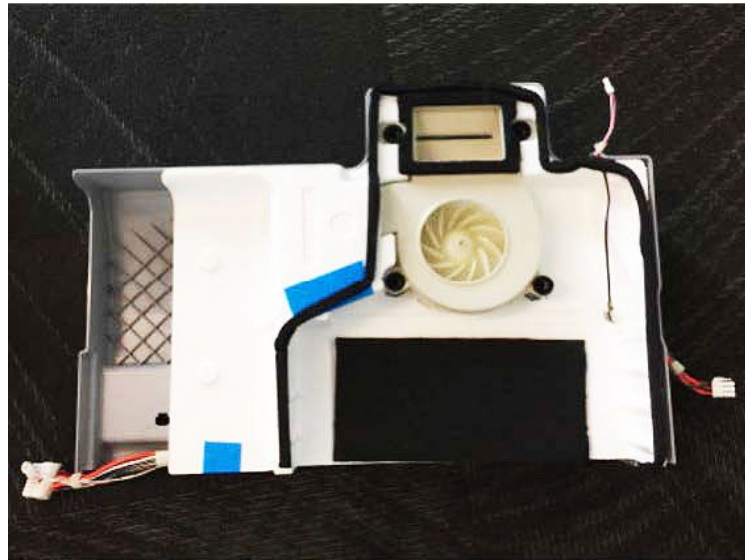
**Figure 6 - EVAPORATOR COVER WITH CORRECT SEALS**

8. Make sure gaskets look like the photo in figure #6 with proper alignment along edges and no creases or other areas where gaskets may not seal fully against enclosure.

9. Install the replacement cover, push it fully against the back of the liner.
10. Install the new Control board on the rear of the refrigerator.
11. Reinstall the compressor machine cover.
12. Confirm using diagnostics that each component is operating and connected properly.
  - a. Confirm that the RC and FC Fan functions.
  - b. Confirm thermistors reads expected temperature.
  - c. Confirm Pantry LED Functions
  - d. Confirm Isolation Valve functions
  - e. Confirm Ice Maker Auger Motor Functions
